**Project Name and Identification/Location: Malone Residence / # 2416  
2 Scott Street Milford, Connecticut**

# **Limited Hazardous Materials Building Inspection Report**

**RE: Limited Hazardous Materials Building Inspection  
Storm Sandy Residential Rehabilitation Project  
2 Scott Street, Milford, Connecticut**  
Fuss & O'Neill EnviroScience Project No. 20140277.C4E  
Quisenberry Arcari Project No. 1346-33

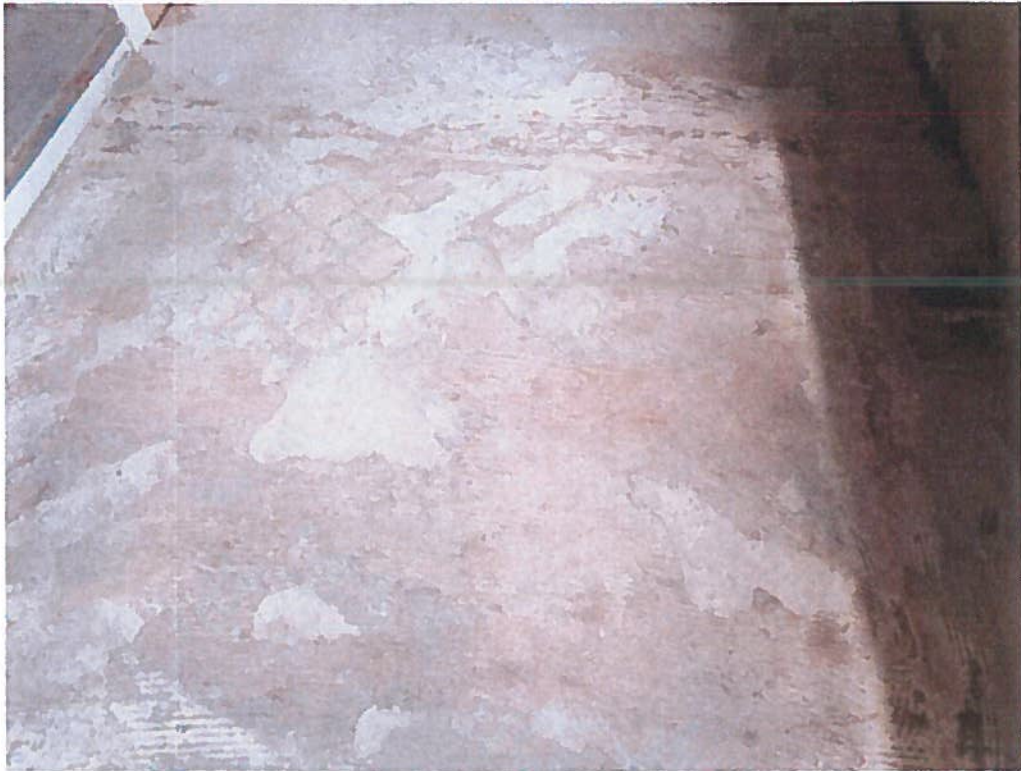
**ACM Kitchen/Dining Room White Sheet Flooring**

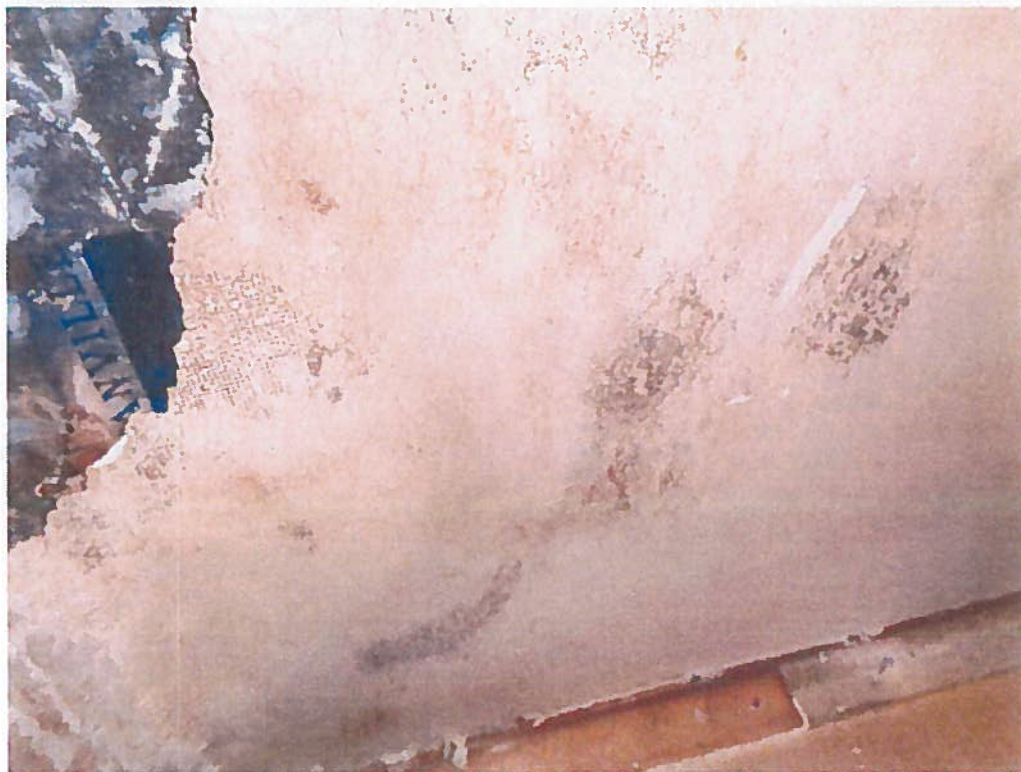
**Visible Mold on Furnace Room Sheetrock Wall**

Potential exposure to mold during renovation should be considered, and appropriate work protection, possible use of engineering controls, and surface treatment of mold on building materials to remain is recommended.

Where feasible, we recommend building materials that are to remain in areas of visible suspect mold growth be cleaned and treated with a mold inhibitor. Remediation of visible suspect mold growth and removal of water-damaged building materials should be performed within a negative pressure enclosure/environment, using properly-trained and protected workers. Removal should comply with guidance according to EPA and the Institute of Inspection, Cleaning and Restoration Certification (IICRC).
